Prioritisation of river sections for restoration based on evidence of geomorphological adjustments (Saja River, Spain)

L. Incera¹, E. Fernández-Iglesias¹, M. Fernández-García¹, V. Moro¹, G. González-Rodríguez¹, D. Vázquez-Tarrío² and R. Menéndez-Duarte^{1,3}

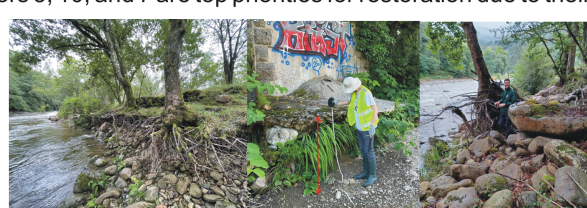
Since 1957, the Saja River has narrowed by 31%, with 12% of sites showing active bank erosion and 43 points with vertical instability (Figure 2). Sectors 3 and 5 have lost the most active channel area (31% and 28%), while sectors 7, 9, and 8 are most affected by artificial interventions (37%, 33%, 28%)(Figure 3). Vertical incision is most severe in sectors 10 and 2, reaching up to 2 metres in sectors 2, 3, 7, and 10. Erosive banks are common in sectors 3, 4, and 7. Considering morphodynamic conditions, sectors 3, 10, and 7 are top priorities for restoration due to their severe imbalance and recovery potential (Table 2).

Figure 2.Examples of field evidence: bank erosion and incision in the Saja River.

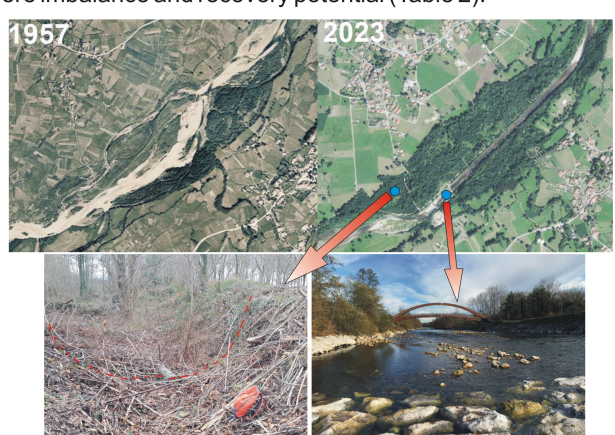
Figure 3. Evidence of secondary channel loss and river channelisation in the Saja River
