Removing small dams: and now, what do I do with the sediment?

Lessons learned

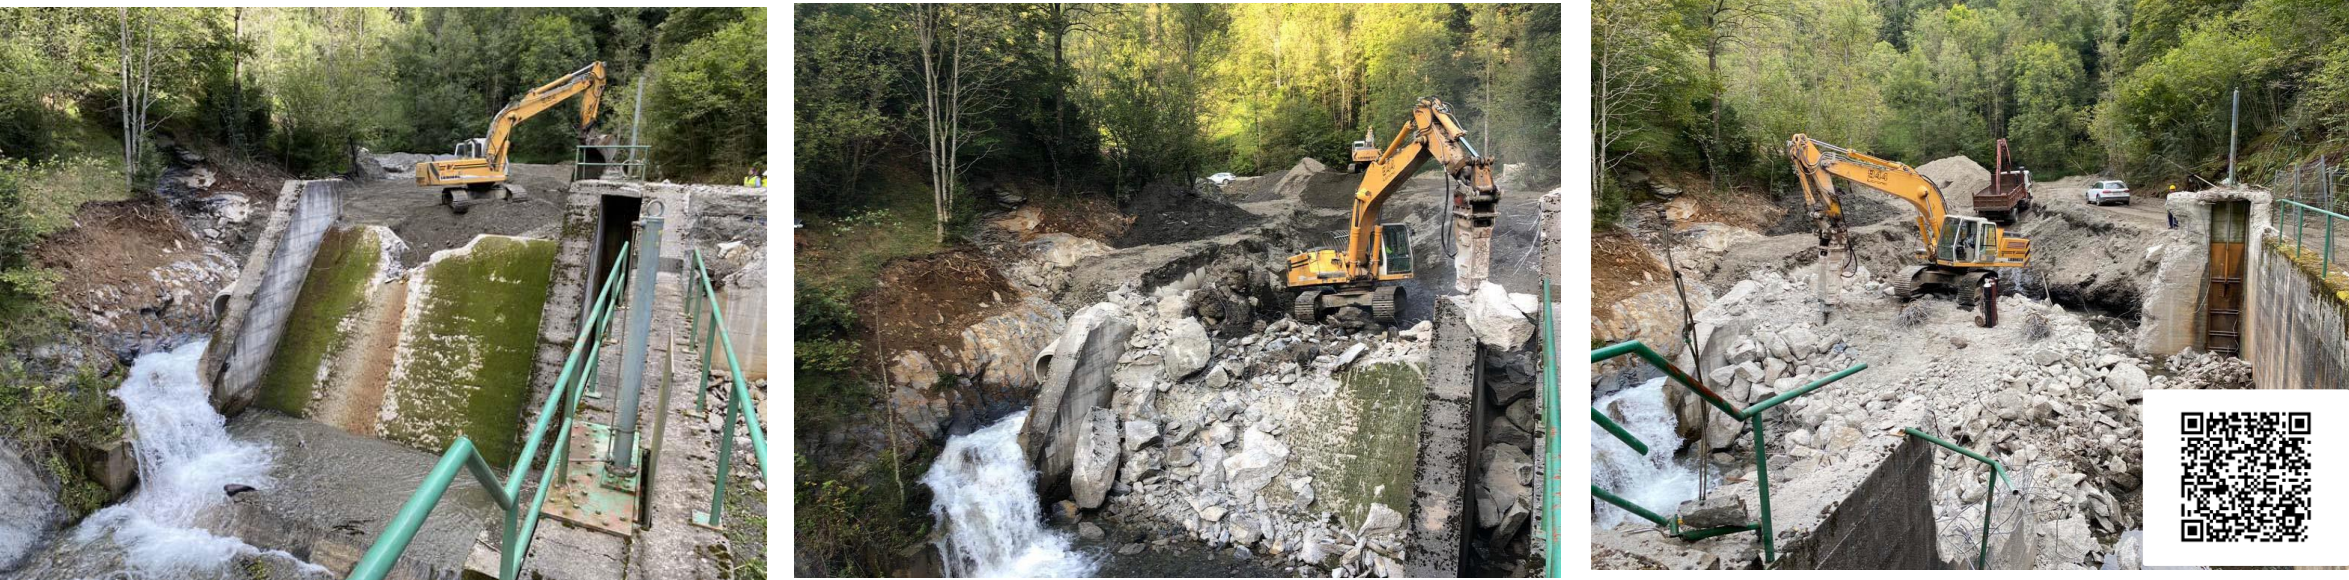
In October 2020, the Ritort Hydroelectric Power Station 8-meter-high dam, full filled by approximately 4,000 m³ of gravel and pebbles, was demolished in a single phase (Fig. 5).

Figure 5. Demolition works of the Ritort Hydroelectric Power Station in October 2020.

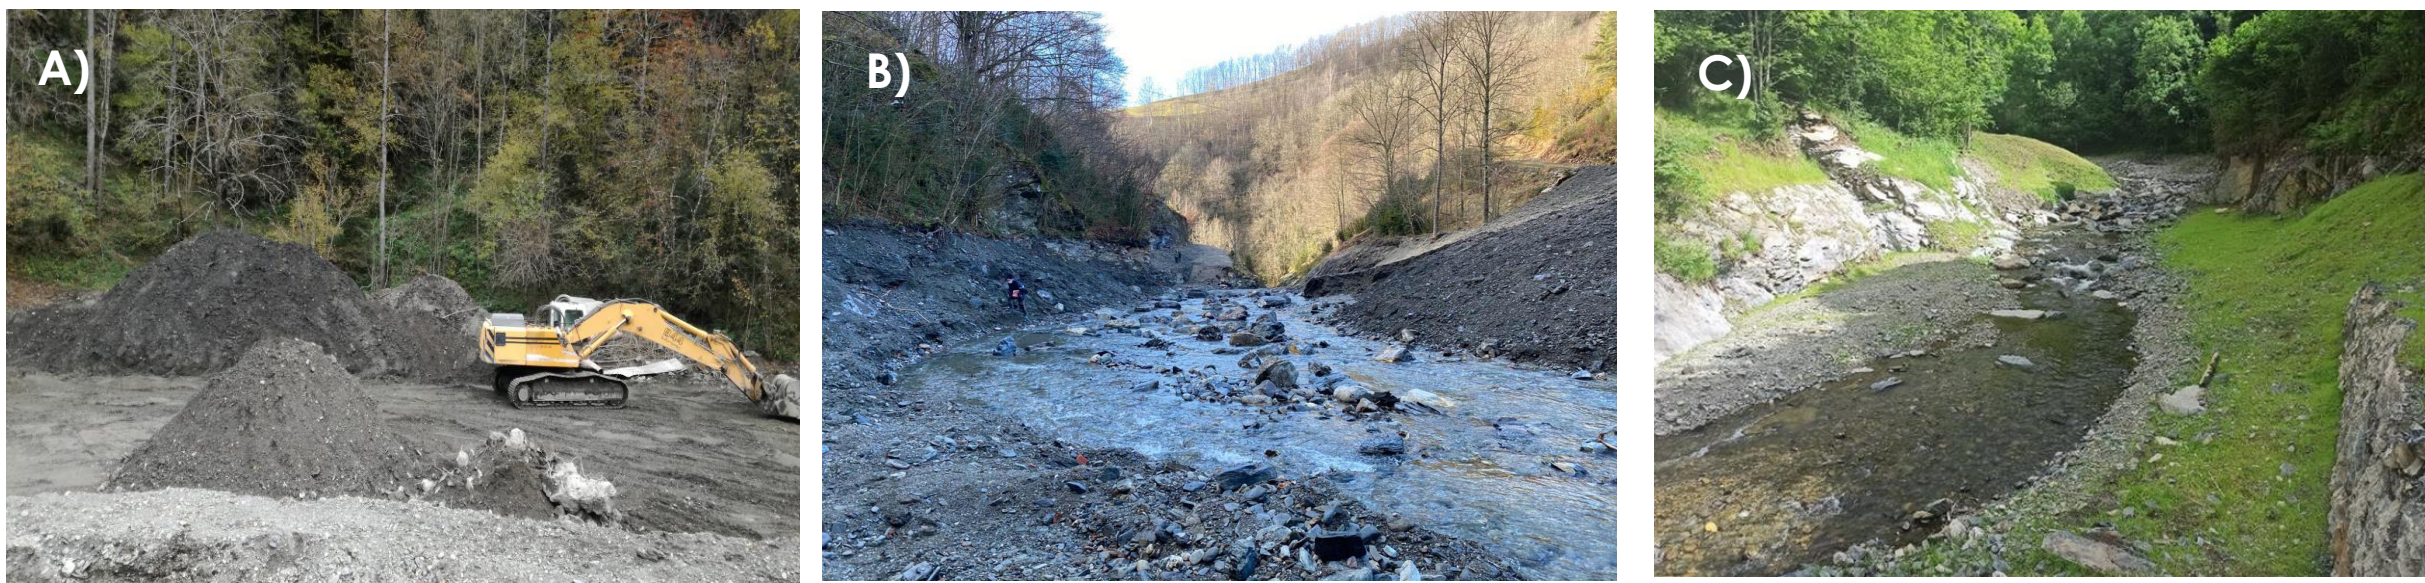
However, the demolition project did not consider how to manage the volume of sediment retained by the dam. As a preventive measure, between 60% and 70% of the total sediment trapped was extracted; since any study available on the (potential) mobility of the sediment during floods nor any idea of the river reach length that could be affected. In parallel to these works, the longitudinal slope of the river in the old dam reservoir was softened and a low-water channel was built.

Figure 6. A) Extraction of the sediment trapped into the reservoir; B) New channel form of the Ritort River after demolition works; C) River channel after one-year.

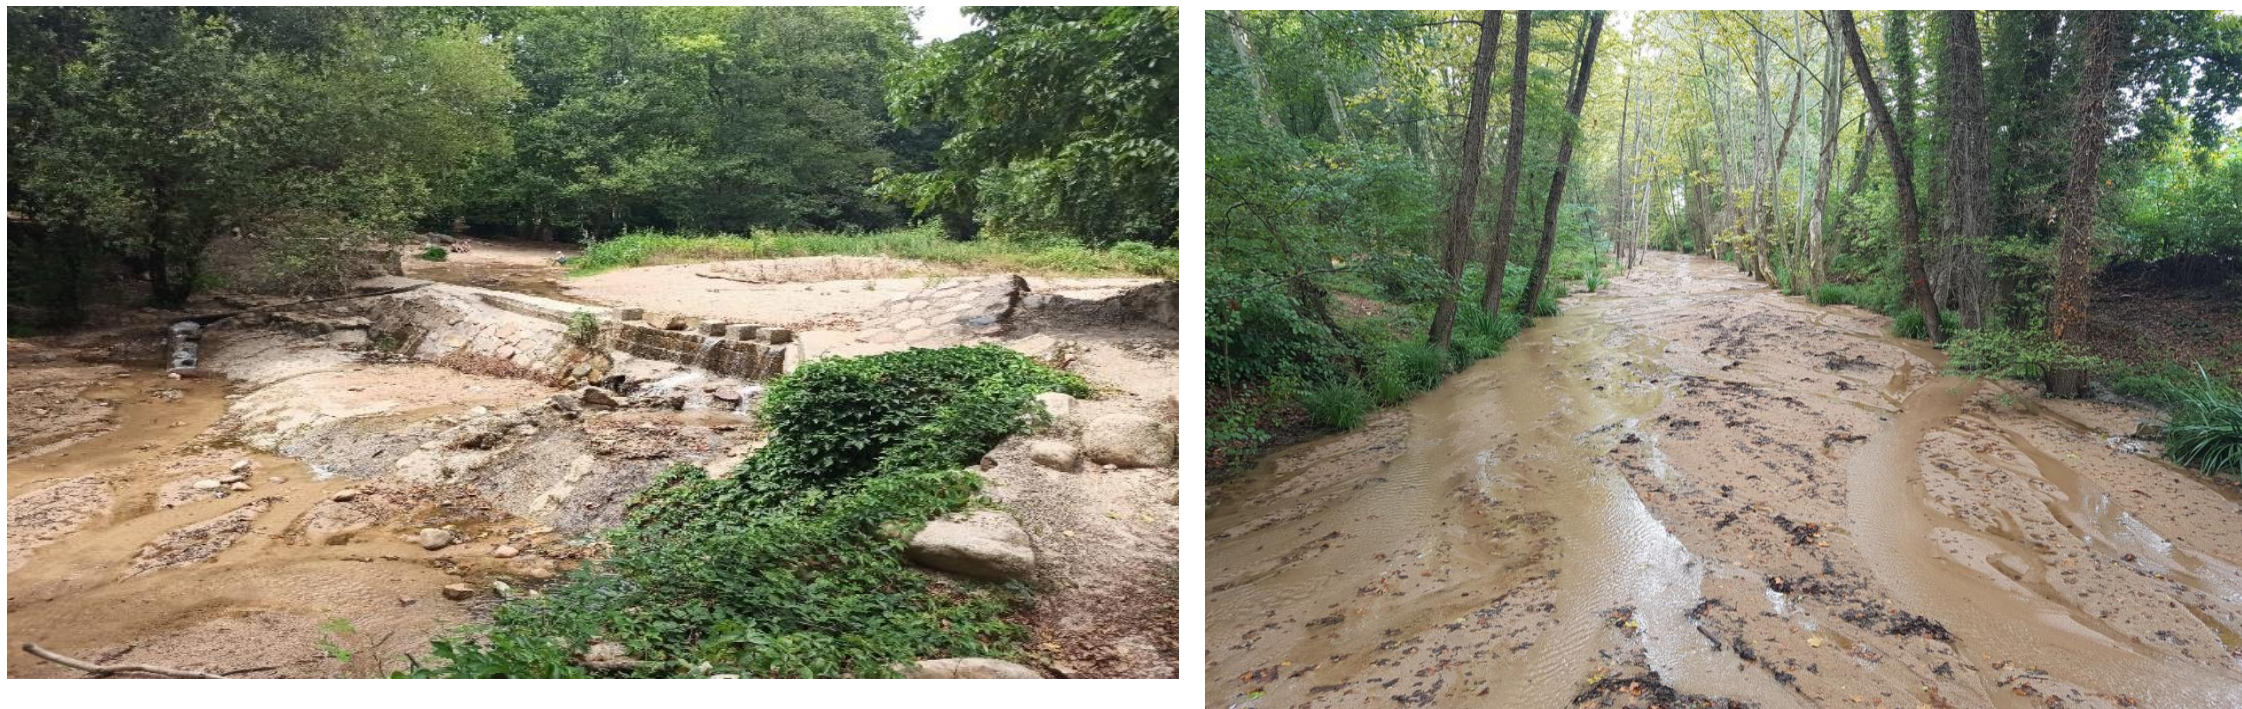
The Sant Salvador dam is an structure made up of two consecutive dams: the first with a height of about 2 m and a length of 20 m, and the second (Fig. 7) with a height of 1.7 m and about 30 m long.

Figure 7. View of the Sant Salvador dam

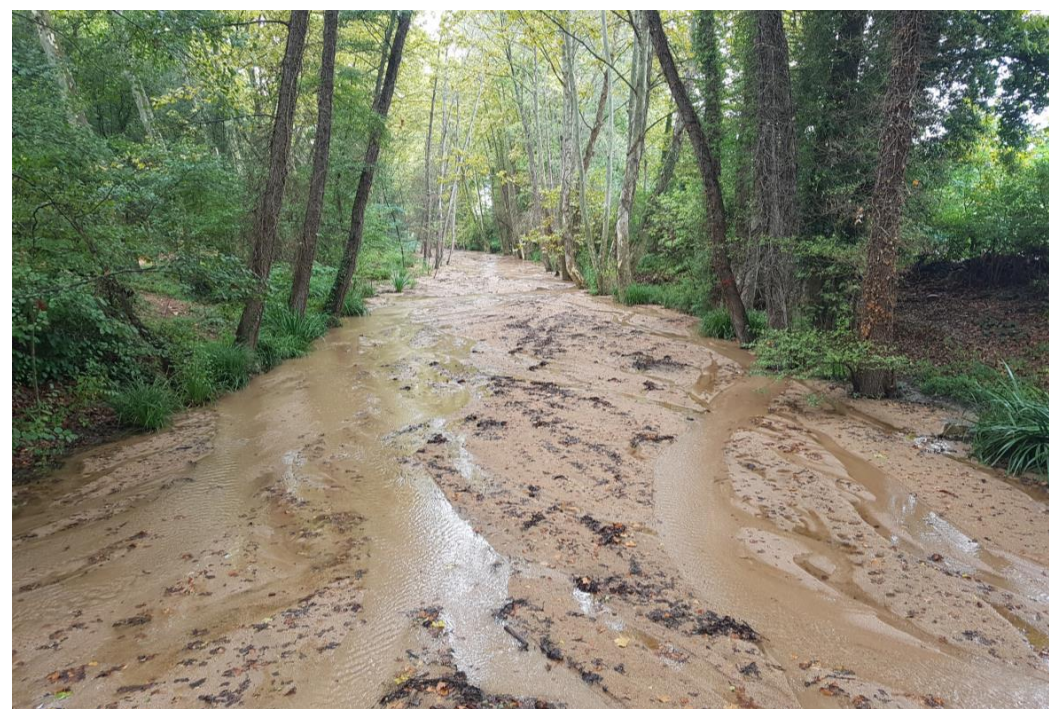
In 2021, was registered the most significant flood since 1995. As a result, the dam acted as a sediment trap and the reservoir was absolutely filled (Fig. 8) with a direct impact on the riparian forest and aquatic habitats.

Figure 8. View of the reservoir

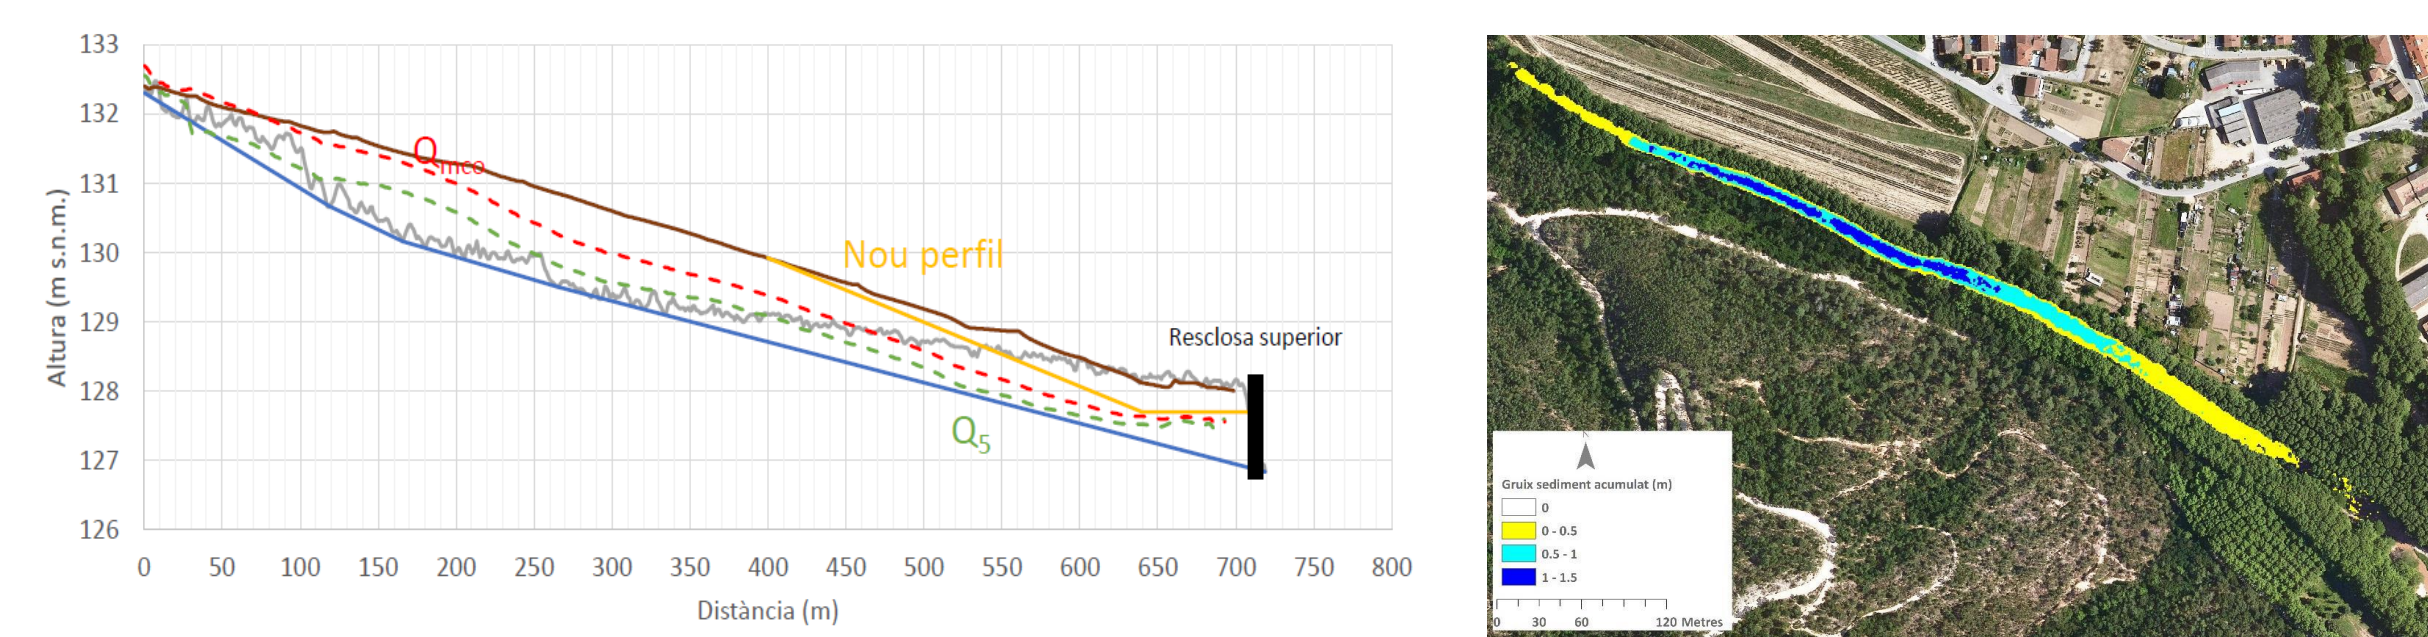
The City Council considered the demolition of the dam and, as a first step, an hydraulic and sediment transport modelling of the river was carried out to evaluate the river bed response under different demolition scenarios (Fig. 9).

Figure 9. Modelling of the riverbed response under different scenarios

The study concluded that the best strategy consisted of a phased demolition, with an initial reduction of 1/3 of the height of the dam, and the mechanical removal of 1,400 m³ of sediment (of the total of 4,500 m³) in the first 350 m upstream of the dam.

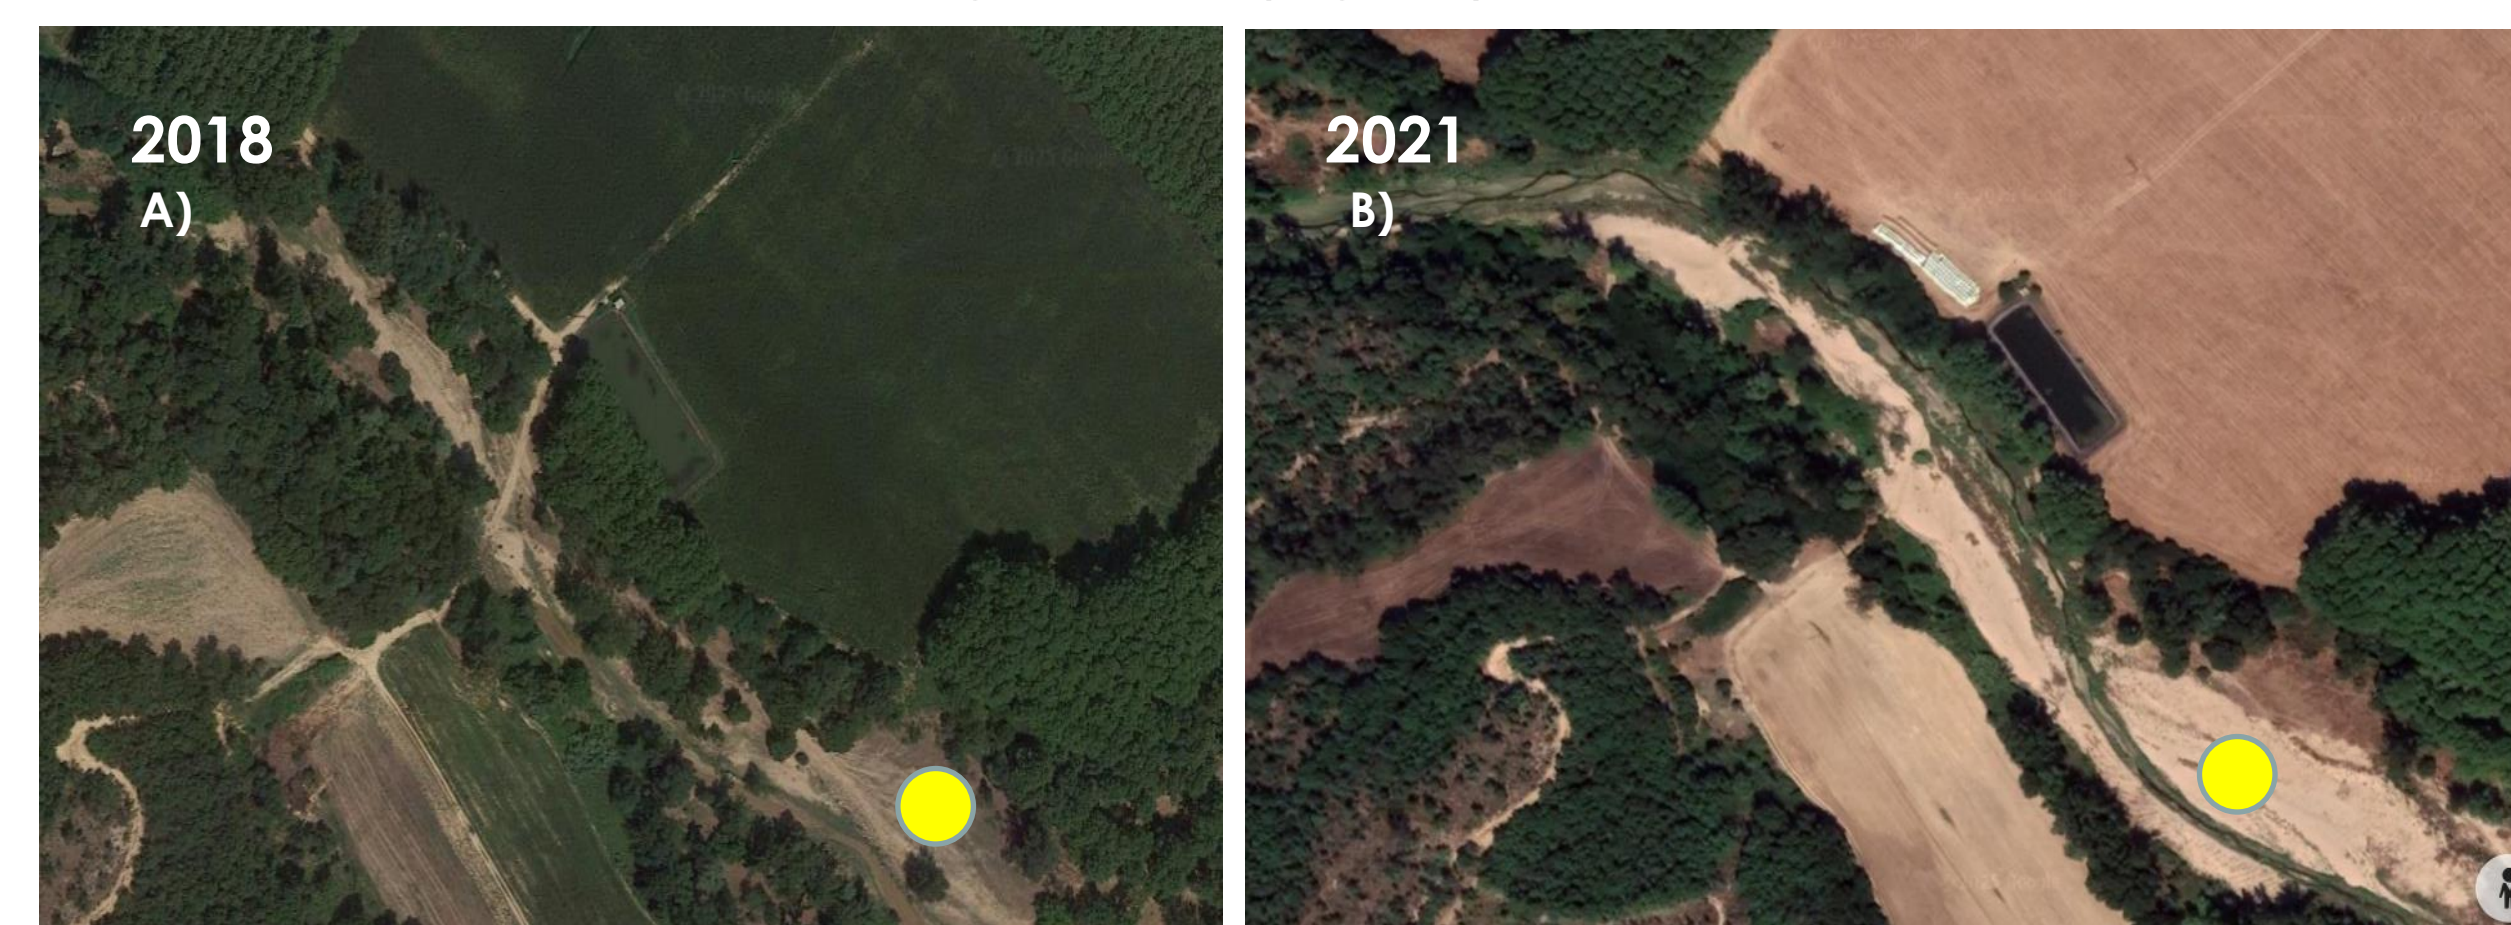
Sediment extracted has been relocated downstream of the dam in sections of the active channel where ordinary floods could mobilize it. These sections were established from the analysis of the existing orthophoto images taken after the extraordinary flooding of 2021 (Fig. 10).

Figure 10. Localization of points in active channel areas where sediment extracted could be relocated: A) 2018; B) 2021

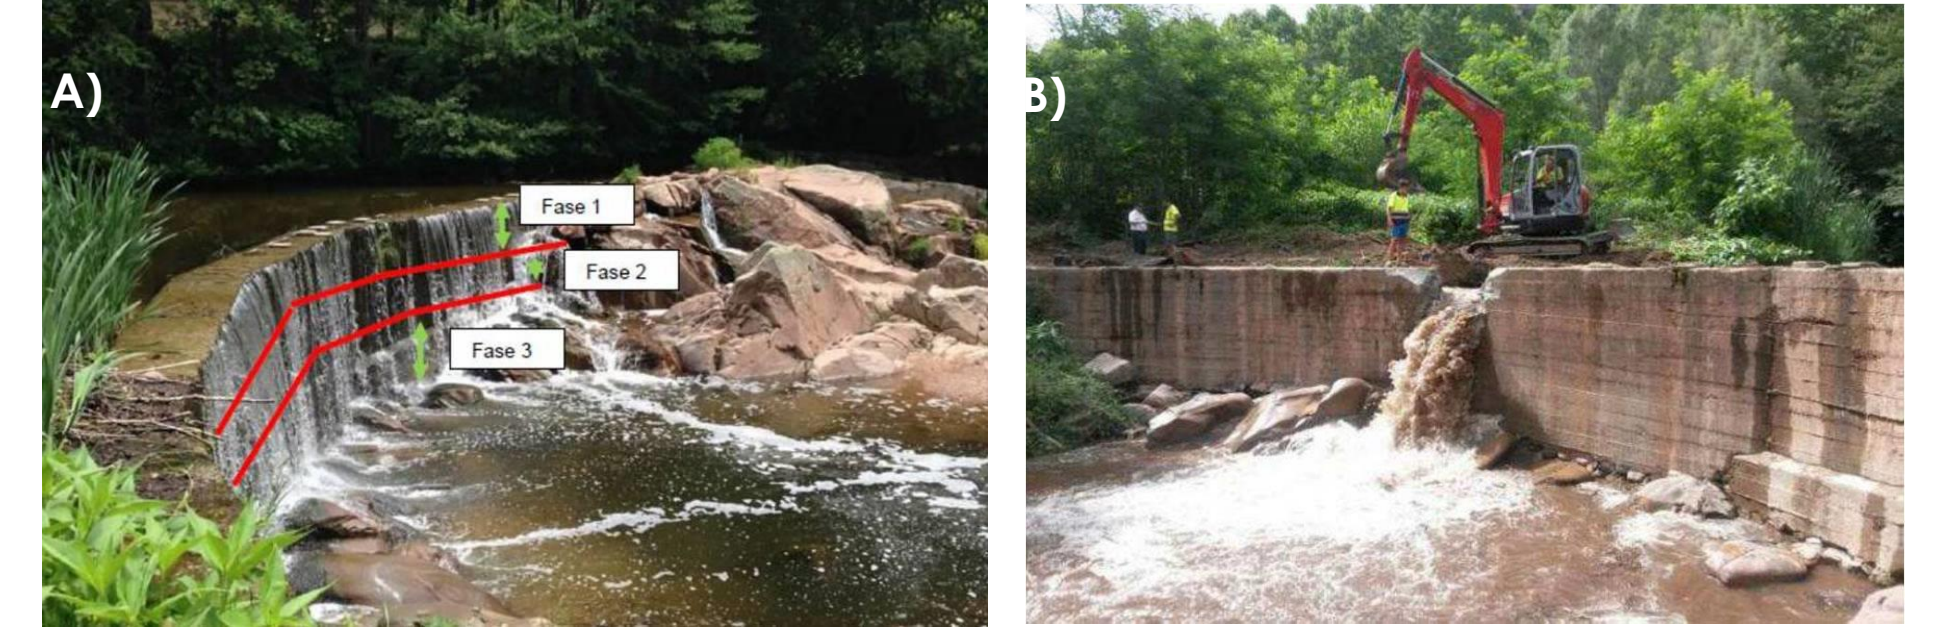
The demolition of the Molí de Bojons dam, in the Riera Major River, was designed in 3 consecutive phases, with the dam being lowered gradually over several years (Fig. 1A). But the demolition project was delayed because administrative reasons and, in October 2017, the dam was demolished in a single phase (Fig 1B). As a preventive measure, around 1,400 m³ of sediment from the total of 9,300 m³ of medium and coarse sand computed to be retained into the reservoir, were removed by mechanical means.

Figure 1. A) Initial design of the Bojons Mill dam demolition project; B) Demolition works of the small dam in January 2018

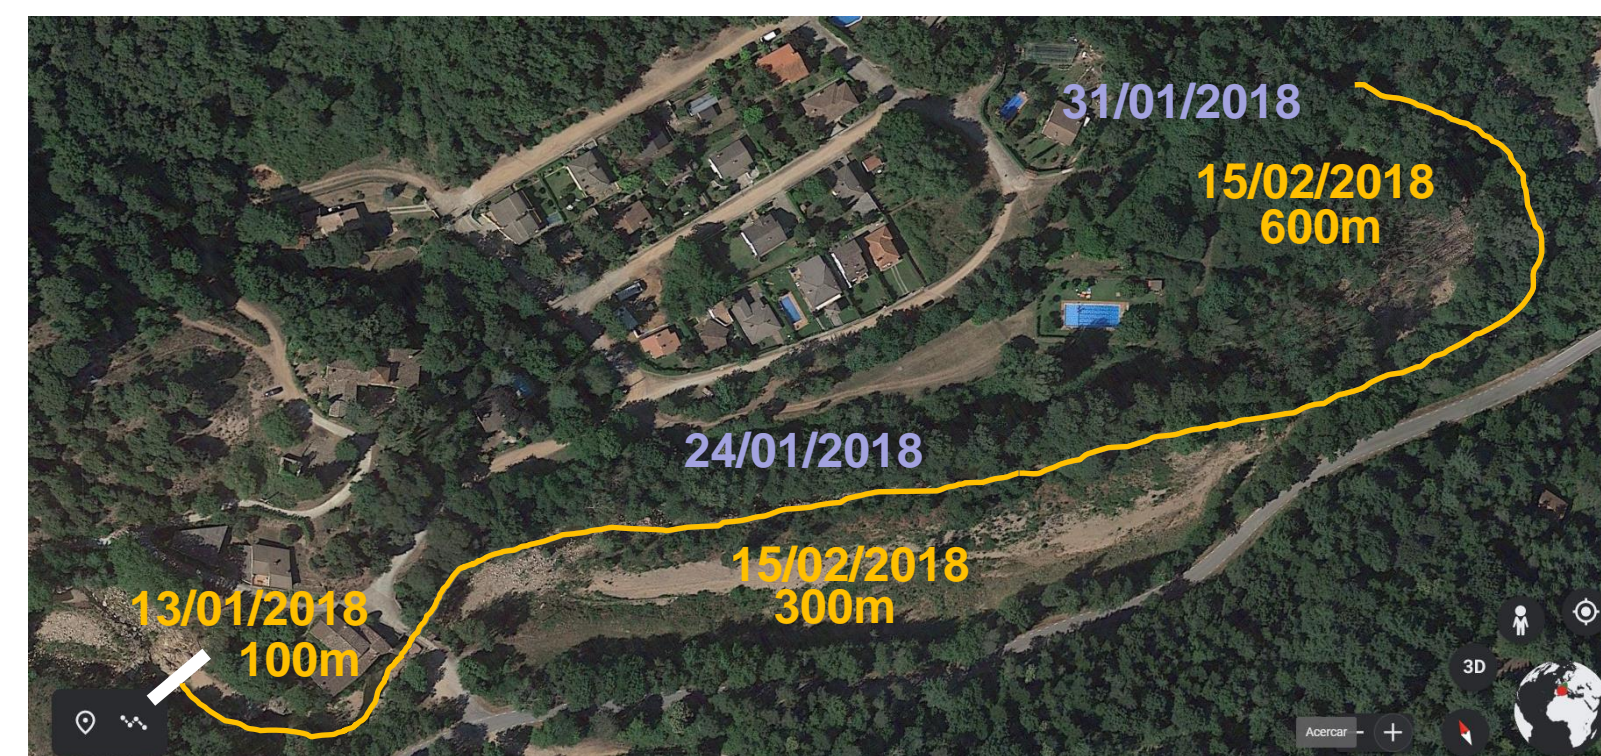
In spite, a massive mobilisation of the material package occurred (Fig. 2) and led to the total modification of the riverbed with a strong consequence on the ecosystem (Fig. 3A i B).

Figure 2. Progress of the sediment wave over time. Data in blue, wave not detected, in gold, wave detected.

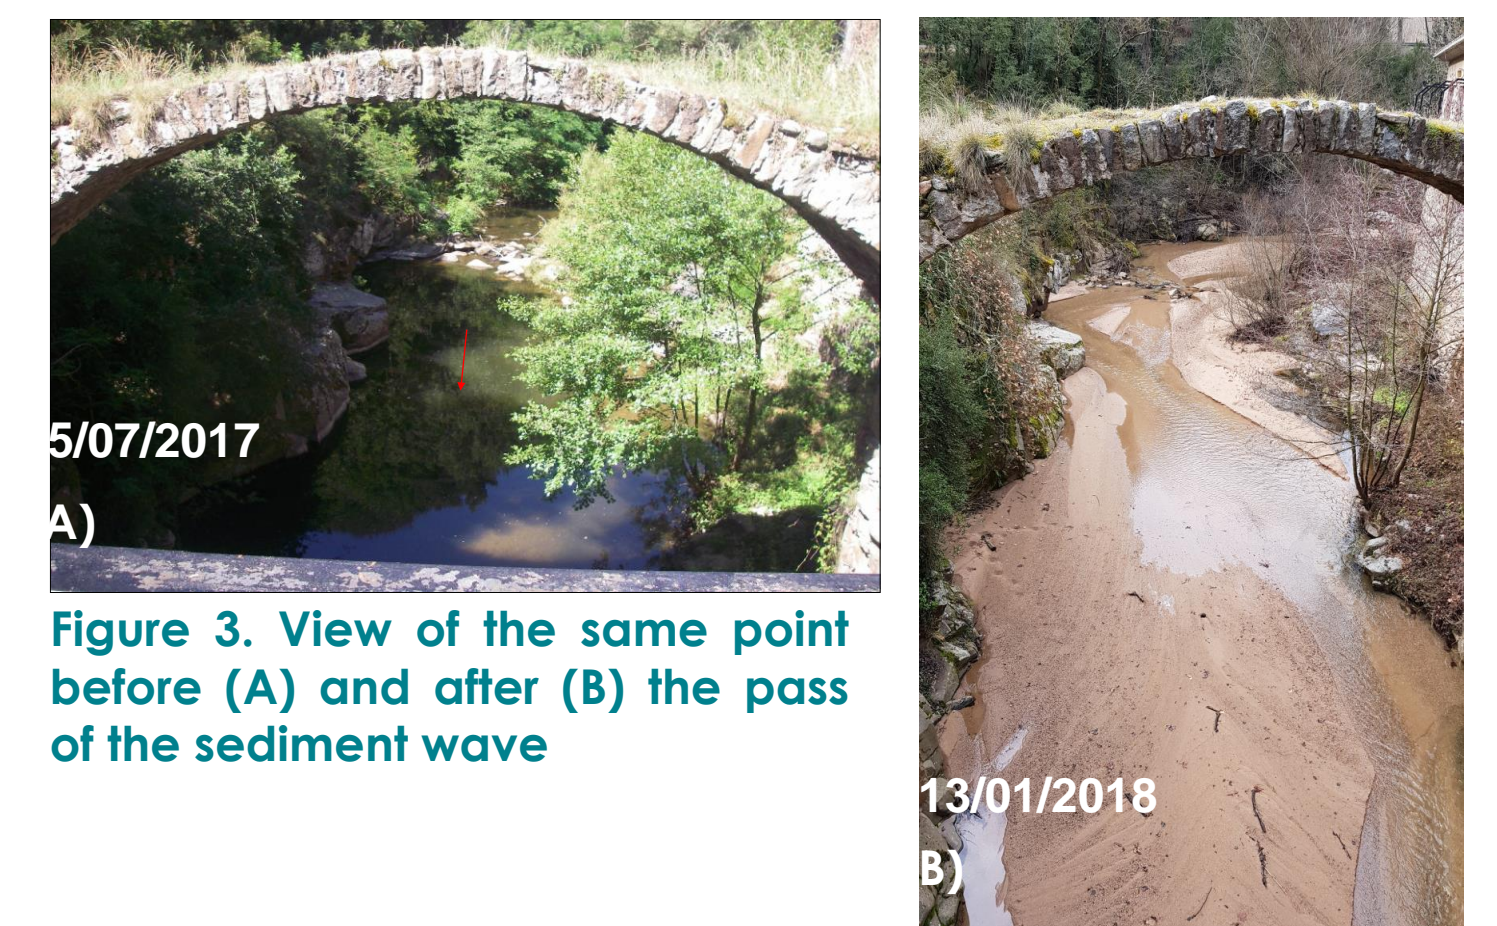
Figure 3. View of the same point before (A) and after (B) the pass of the sediment wave

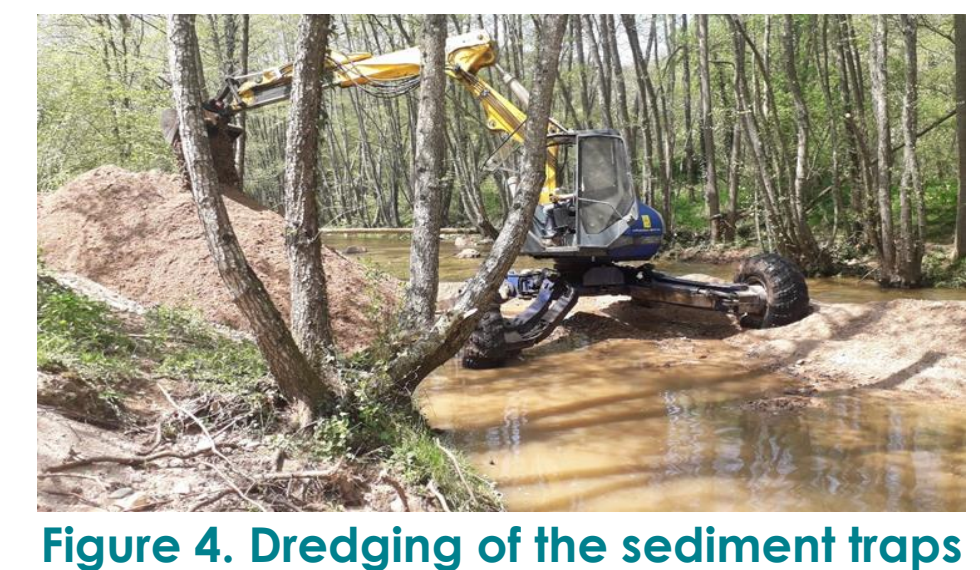
Figure 4. Dredging of the sediment traps

As a corrective measure, three sediment traps were built to slow the advance of the sediment wave and prevent further damage (Fig. 4). In 7 months, around 2000 m³ of sediment was dragged from the traps. In June 2018, a monitoring study of the impact recommended to abandon the use of traps.

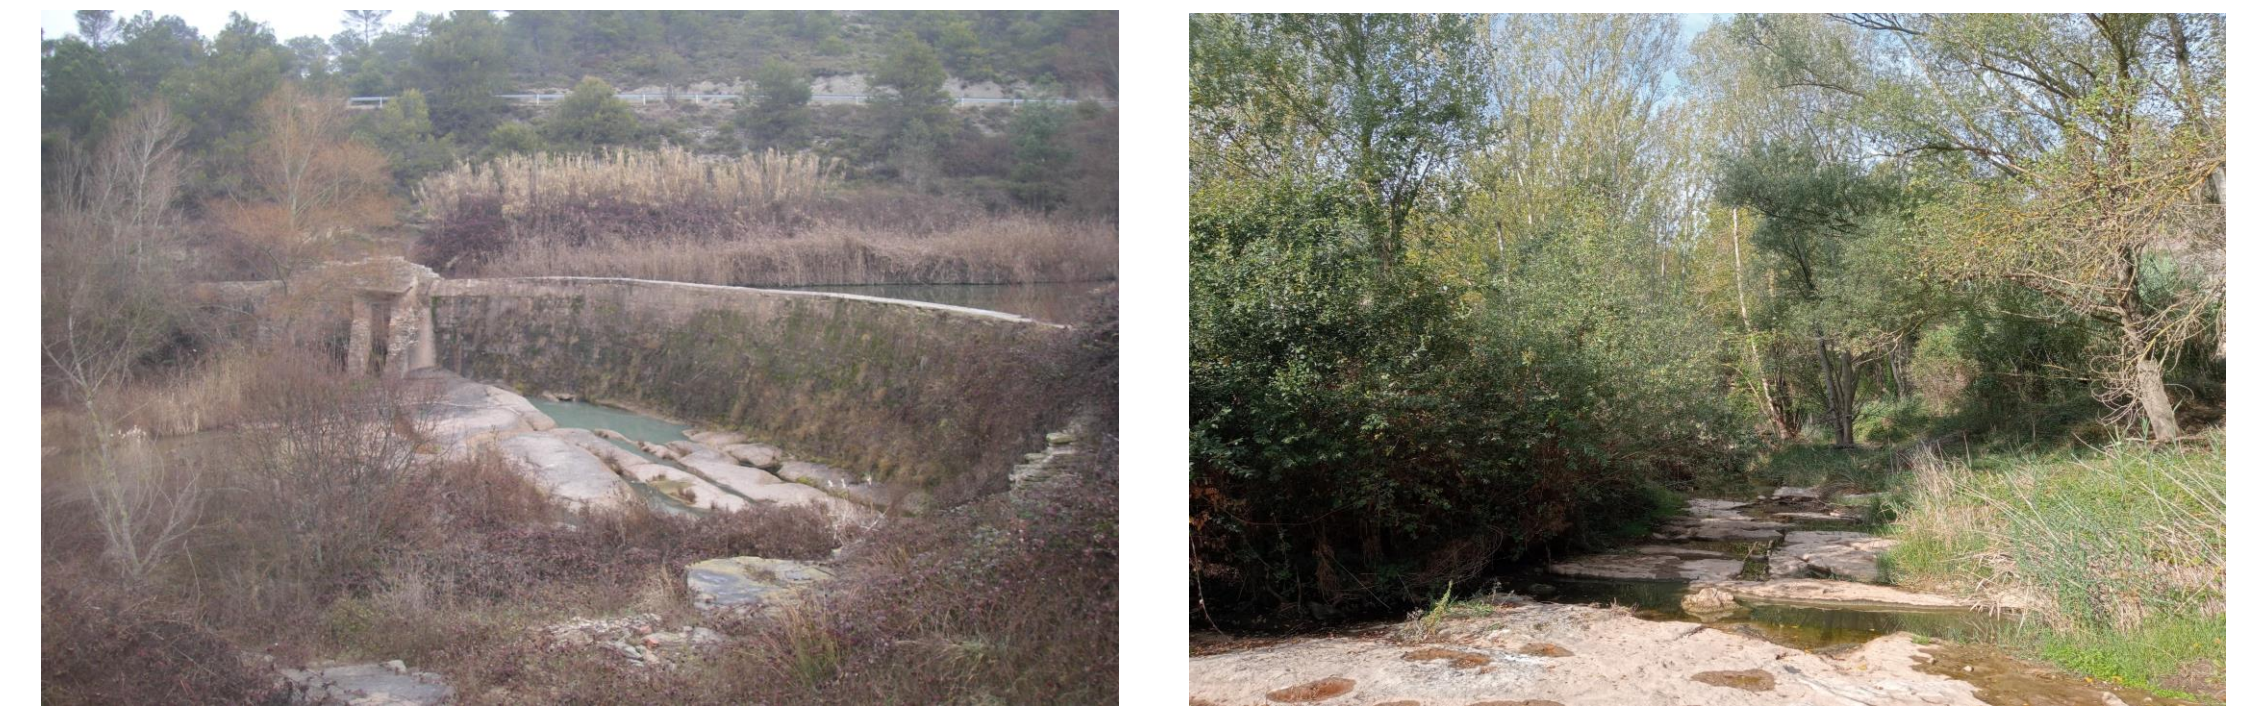
The Colonia Rio dam (Fig. 11A), located in the Calders River, was a 5.6-meter-high and 56-meter-long dam. In its reservoir around 13,000 m³ of sediment was trapped causing a strong sediment deficit. Consequently, some parts of the first 400m of the river channel were bedrock (Fig. 11B) because the sediment exhaustion.

Figure 11. A) General view of the Colonia Rio dam; B) View of the bed rock downstream dam

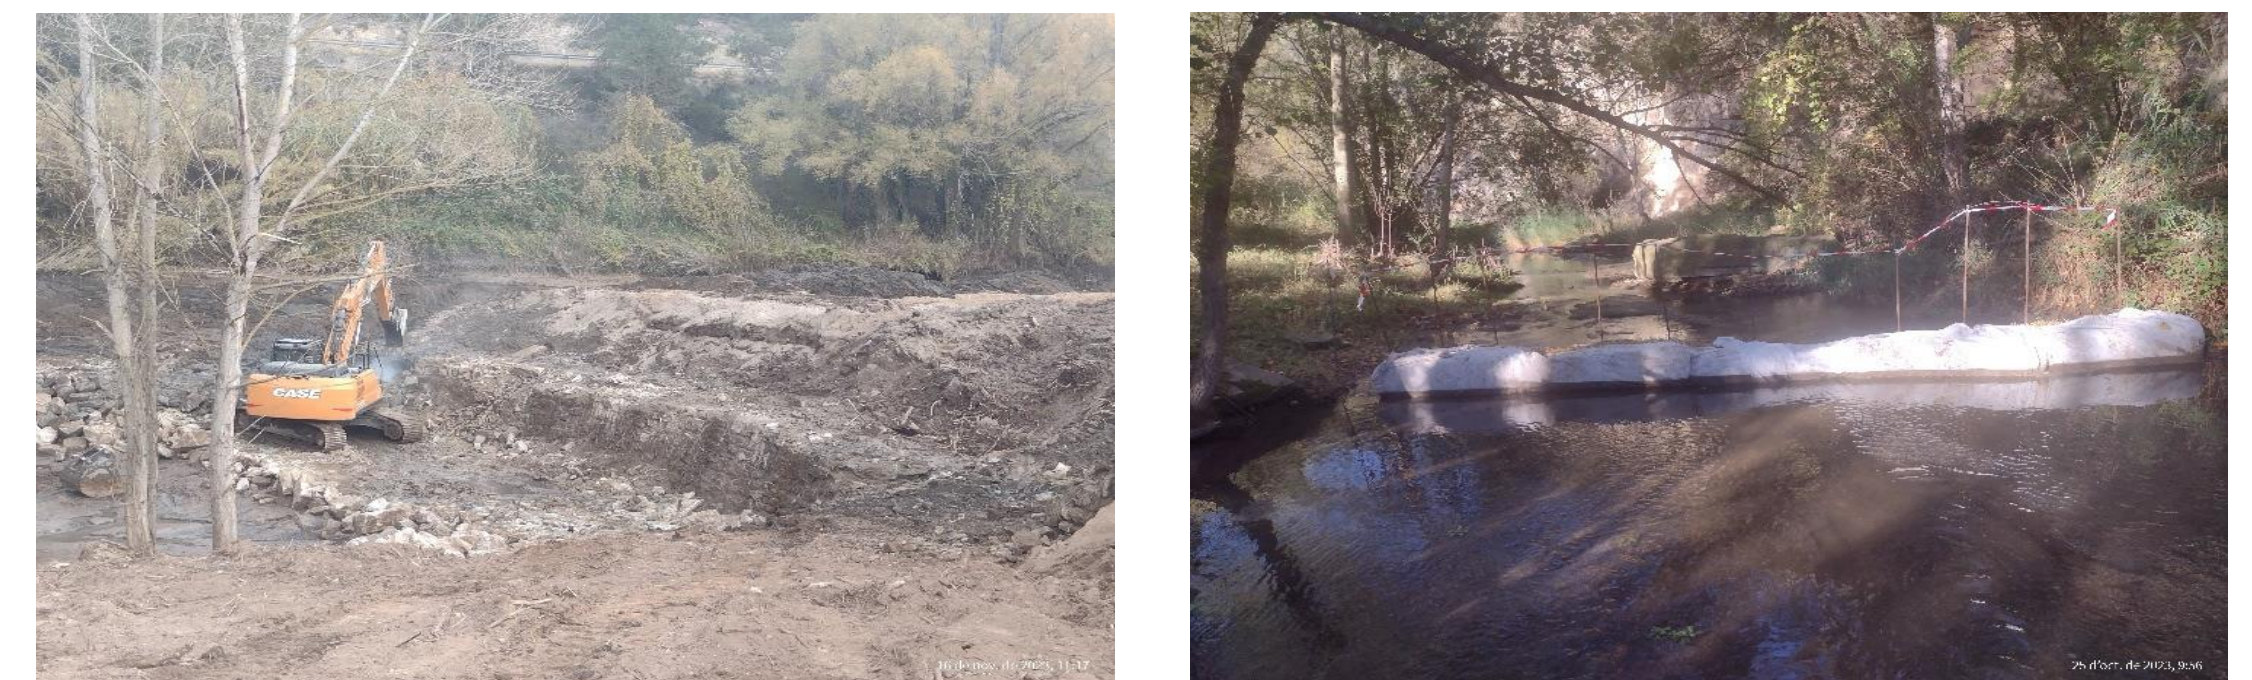
In December 2023, the dam and the diversion canal were demolished in a single phase. A low probability to mass movement was expected because sediments stored into the reservoir were a mixture of sand, gravels, and pebbles. When the dam wall was demolished, an abrupt discontinuity (break slope) was generated in the longitudinal profile of the river (Fig. 12A).

Figure 12. Demolition of the Colonia Rio dam

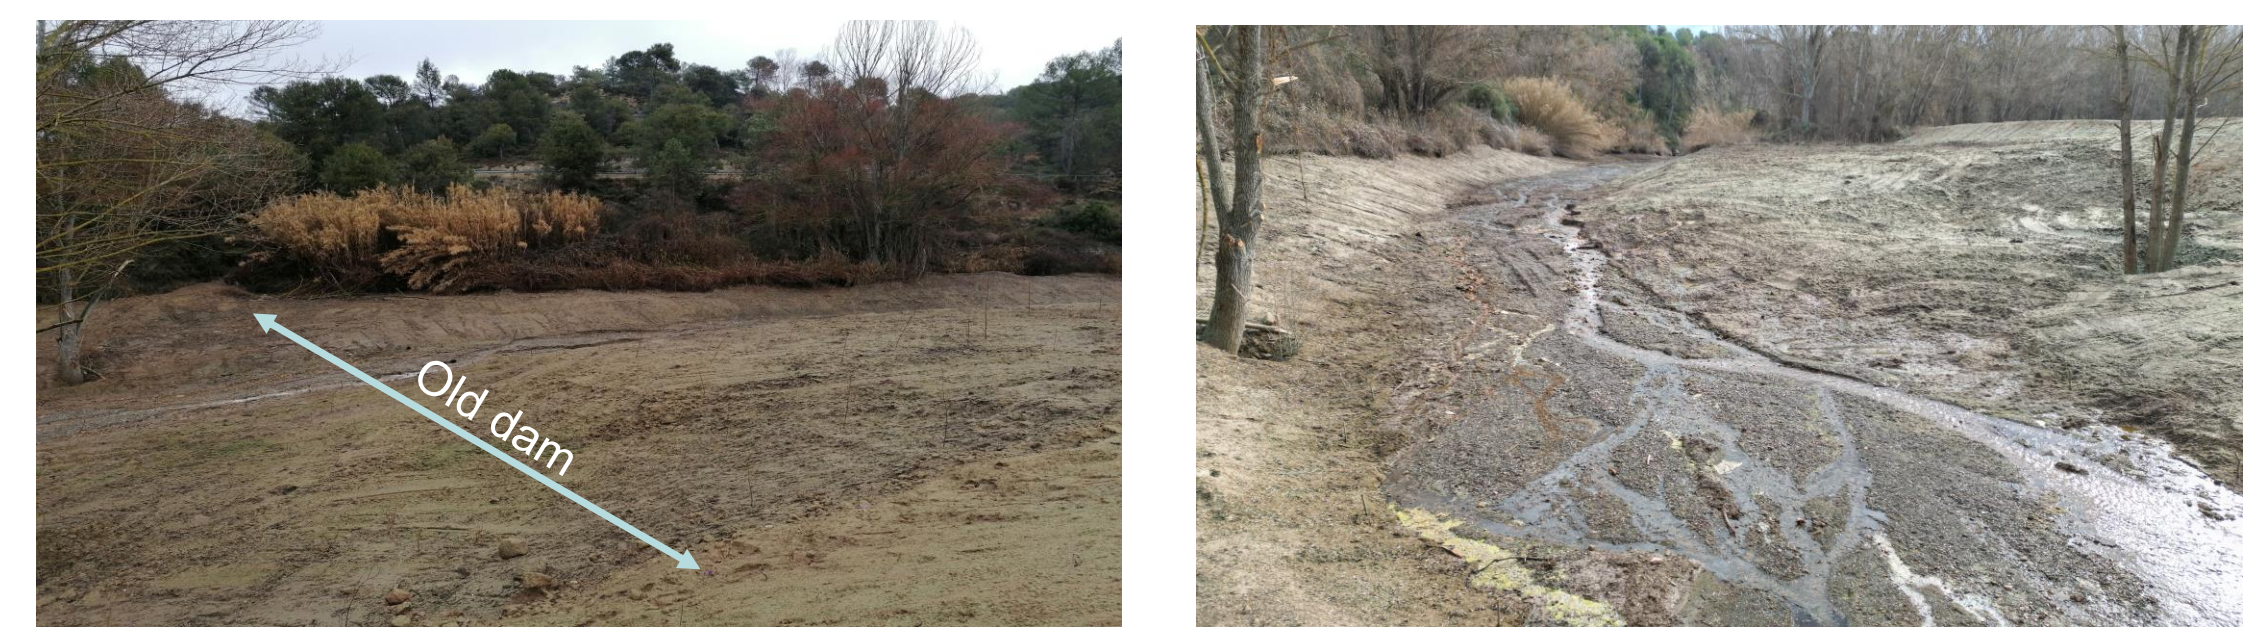
Figure 13. Sediment barriers to reduce turbidity

Figure 14. Relocation of the sediment in front of the old dam

Therefore, part of the sediment retained in the reservoir was relocated at the front of the old dam while a new morphology of the river channel was traced into the reservoir (Fig. 14 & Fig. 15). In addition, a monitoring program was carried out to evaluate the hydromorphological and biological response of the river system.

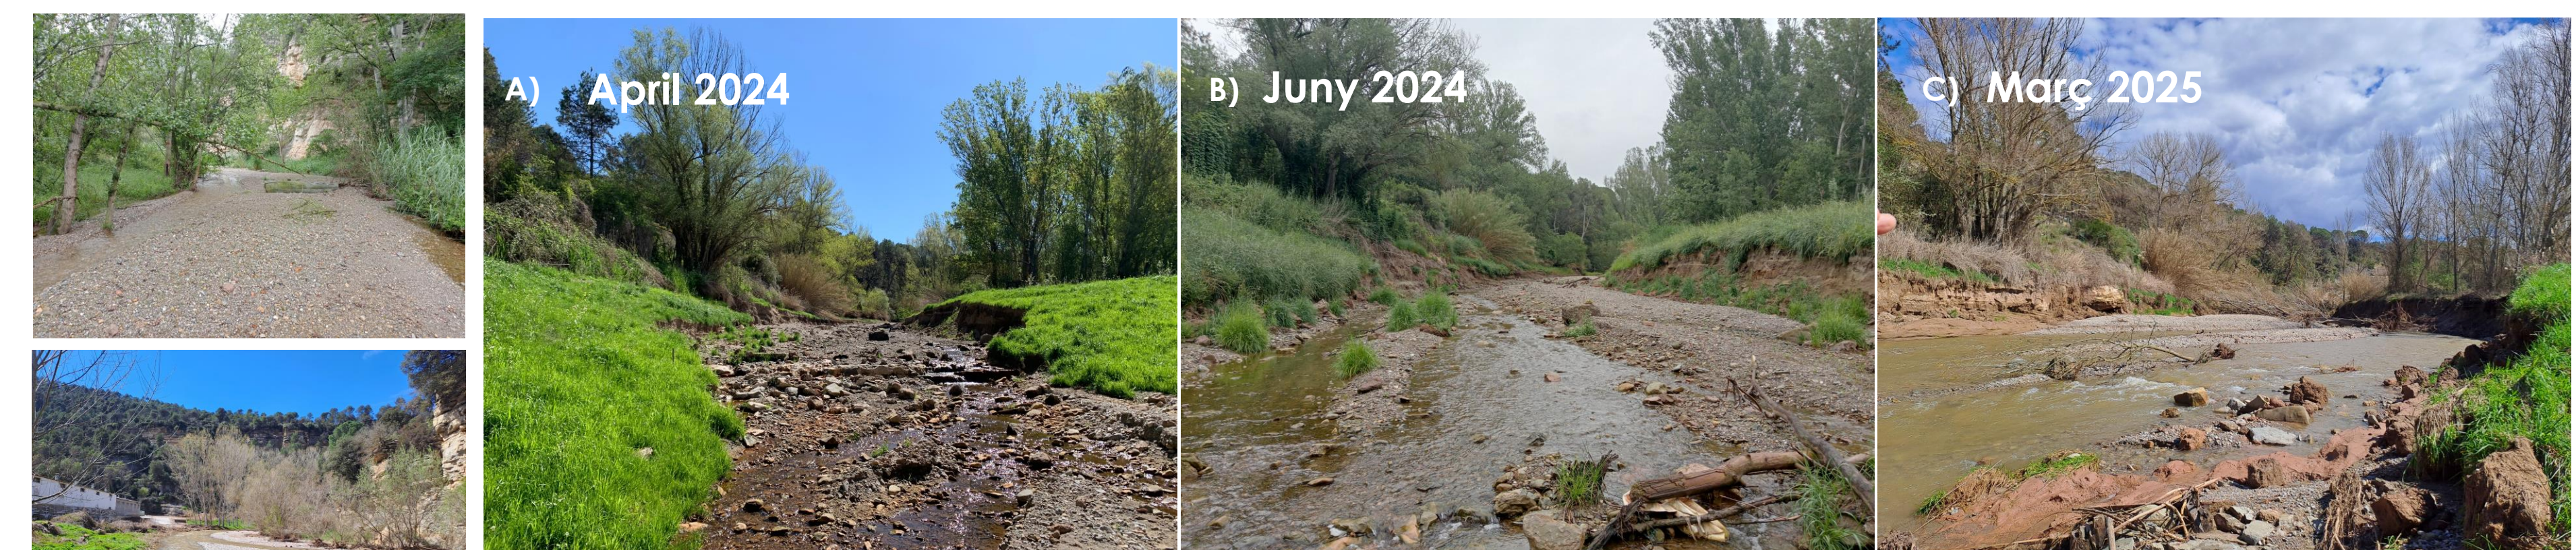
A rapid response of the morphological system after the occurrence of small flood events (Fig. 16).

The sediment deficit was compensated by riverbed accretion (up to 50-100 cm) with the sediment eroded from the sedimentary package (Fig. 17). Furthermore, a braided channel with a complex riverbed morphology was formed.

Figure 16. Evolution of the sediment package retained into the old reservoir: A) April 2024; B) June 2024; C) March 2025

Figure 17. Riverbed accretion downstream dam after demolition. Affected area: 500m river channel length.
