# Bytes and rates: multiple combinations of different remote sensing data for biogeomorphic interaction of river system

RUSNÁK Miloš, GOGA Tomáš, AFZALI Hamid, OPRAVIL Šimon, MICHALEJE Lukáš, MD Ashraf

Institute of Geography SAS, Bratislava, SLOVAKIA

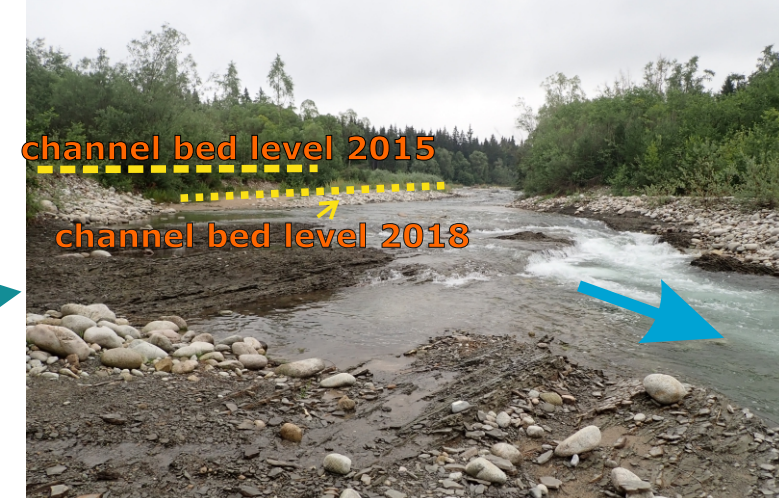
### B - rapid incision

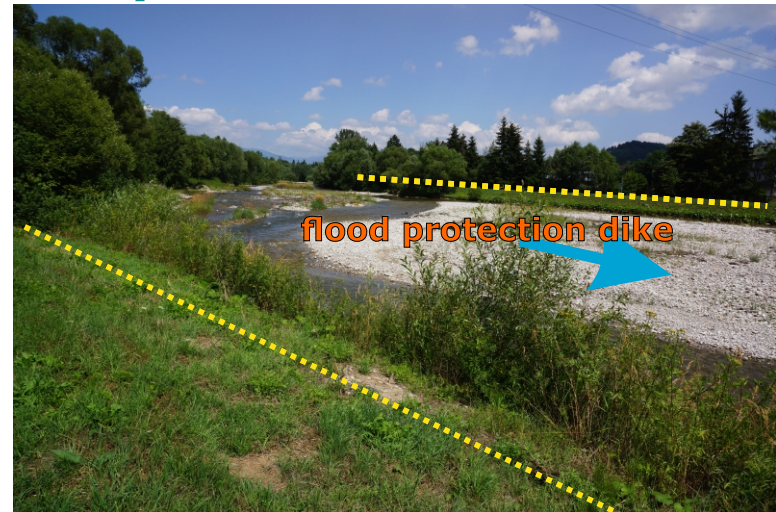
### C - human impact and channelisation

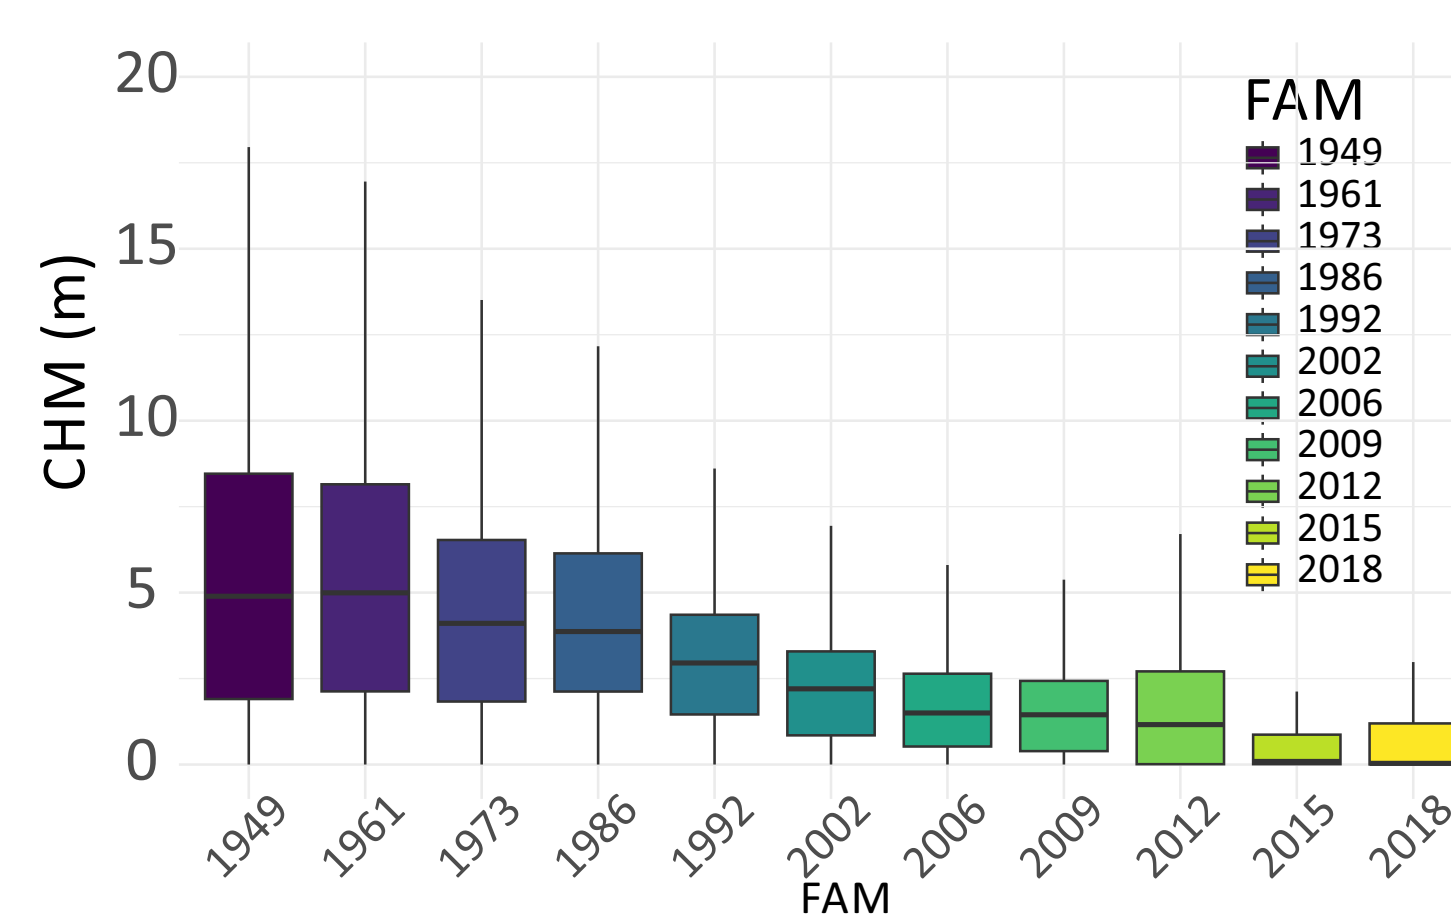
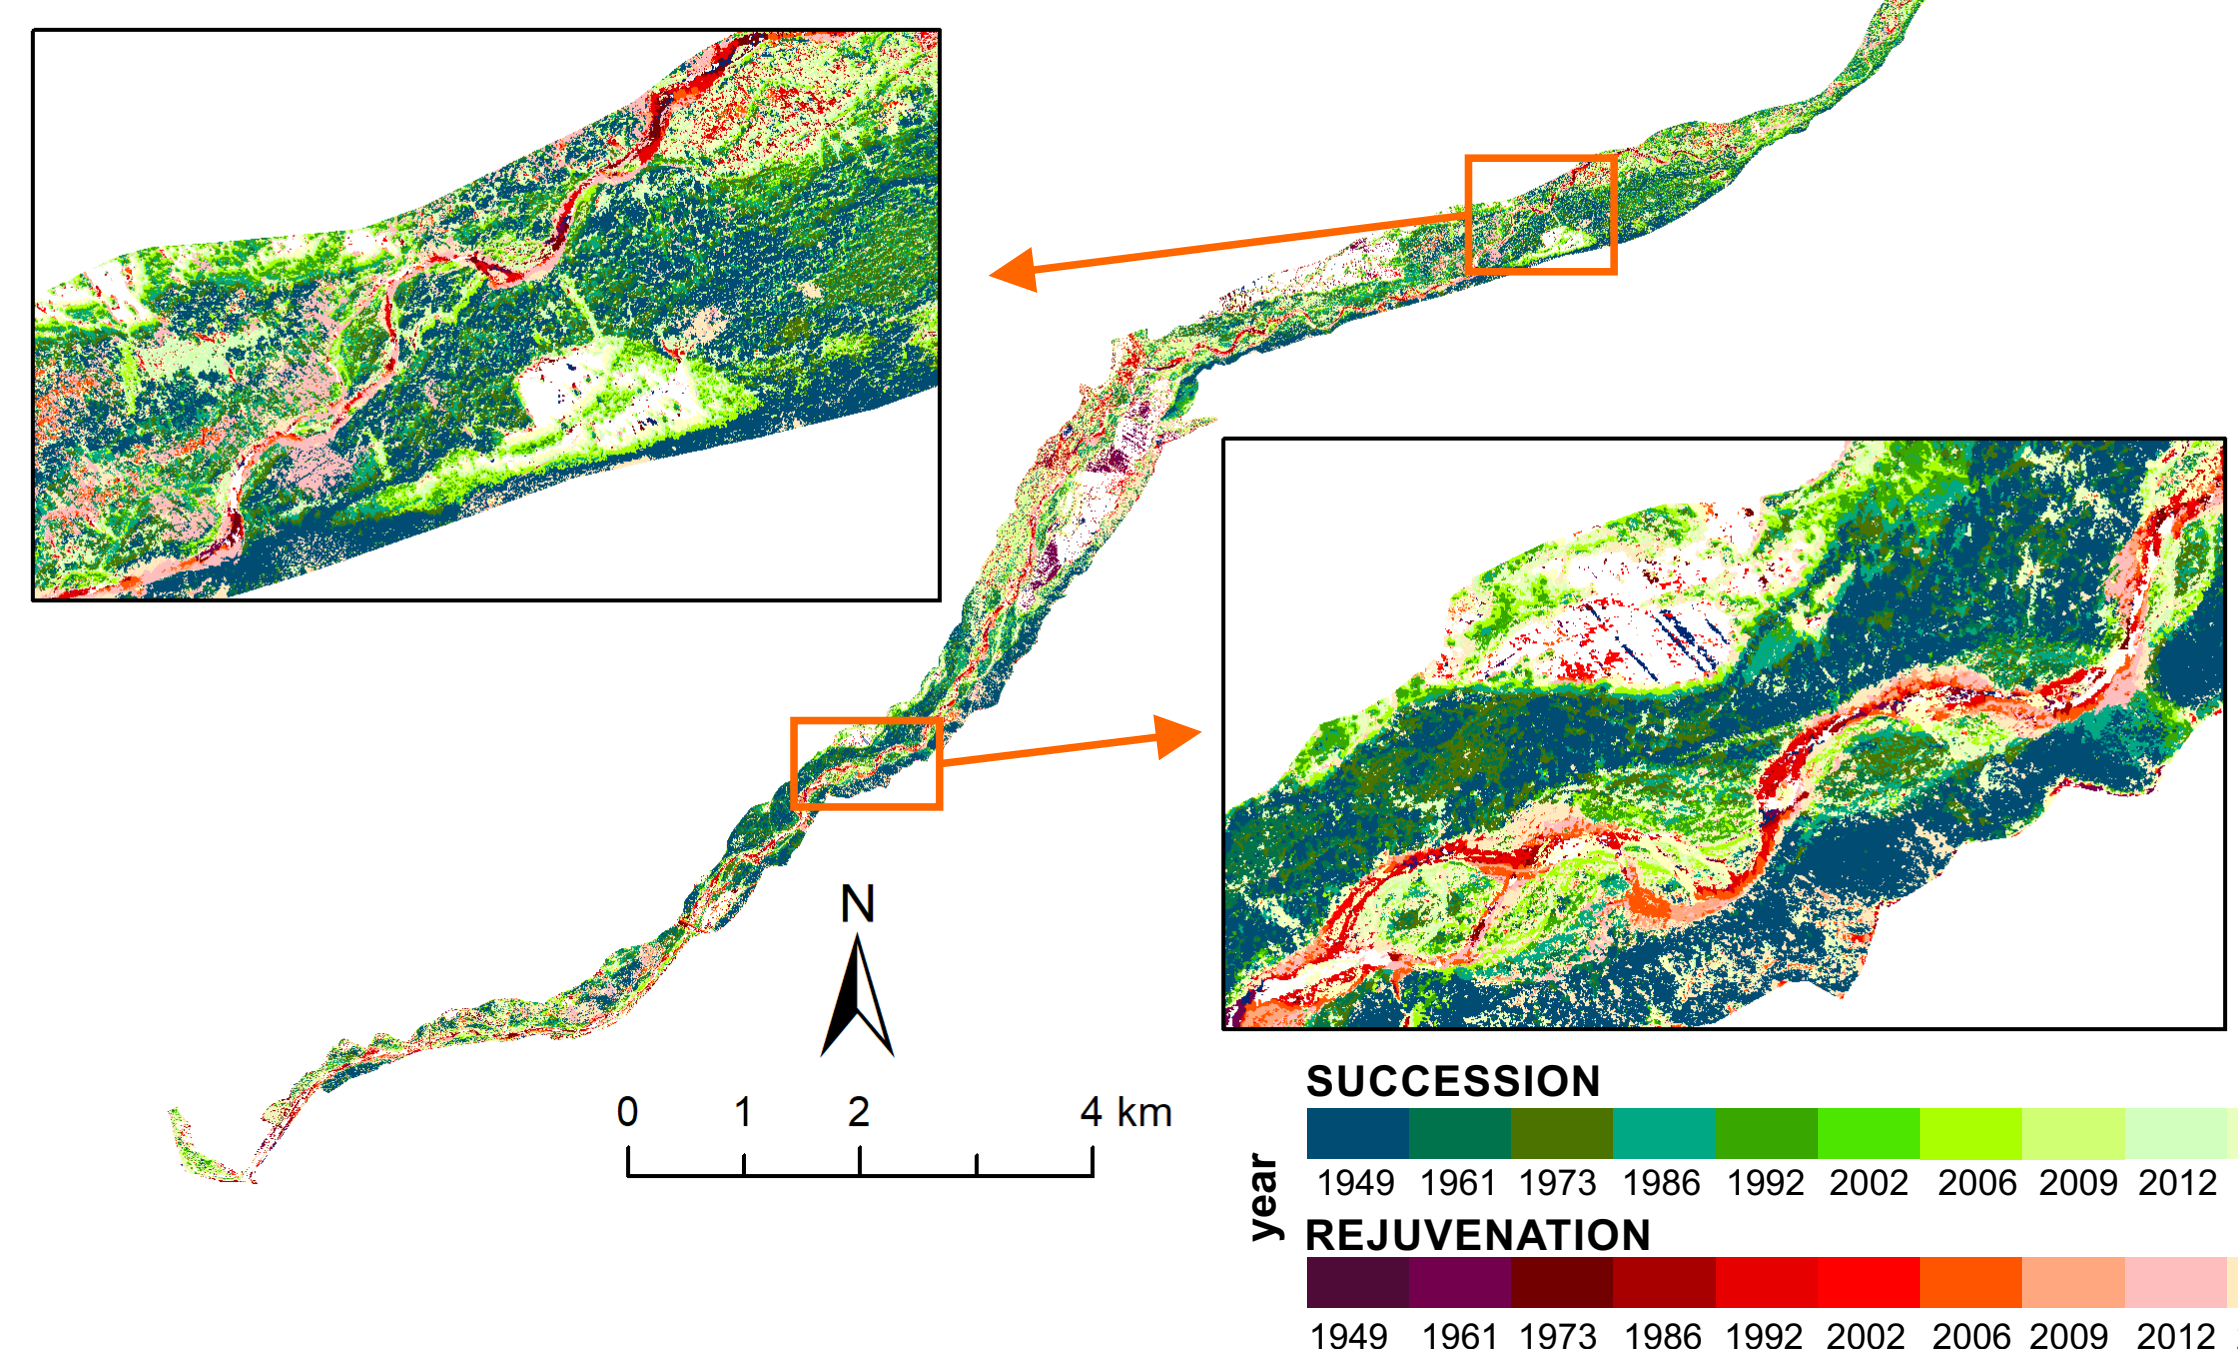
## 5 Biogeomorphic transformation

- increase in riparian vegetation area
- stabilisation of riparian forest belt
- erosion of older stable part (dominantly Picea Abies)
- succession of new forest in form of Salix Sp.
- young forest belt in close proximity of channel

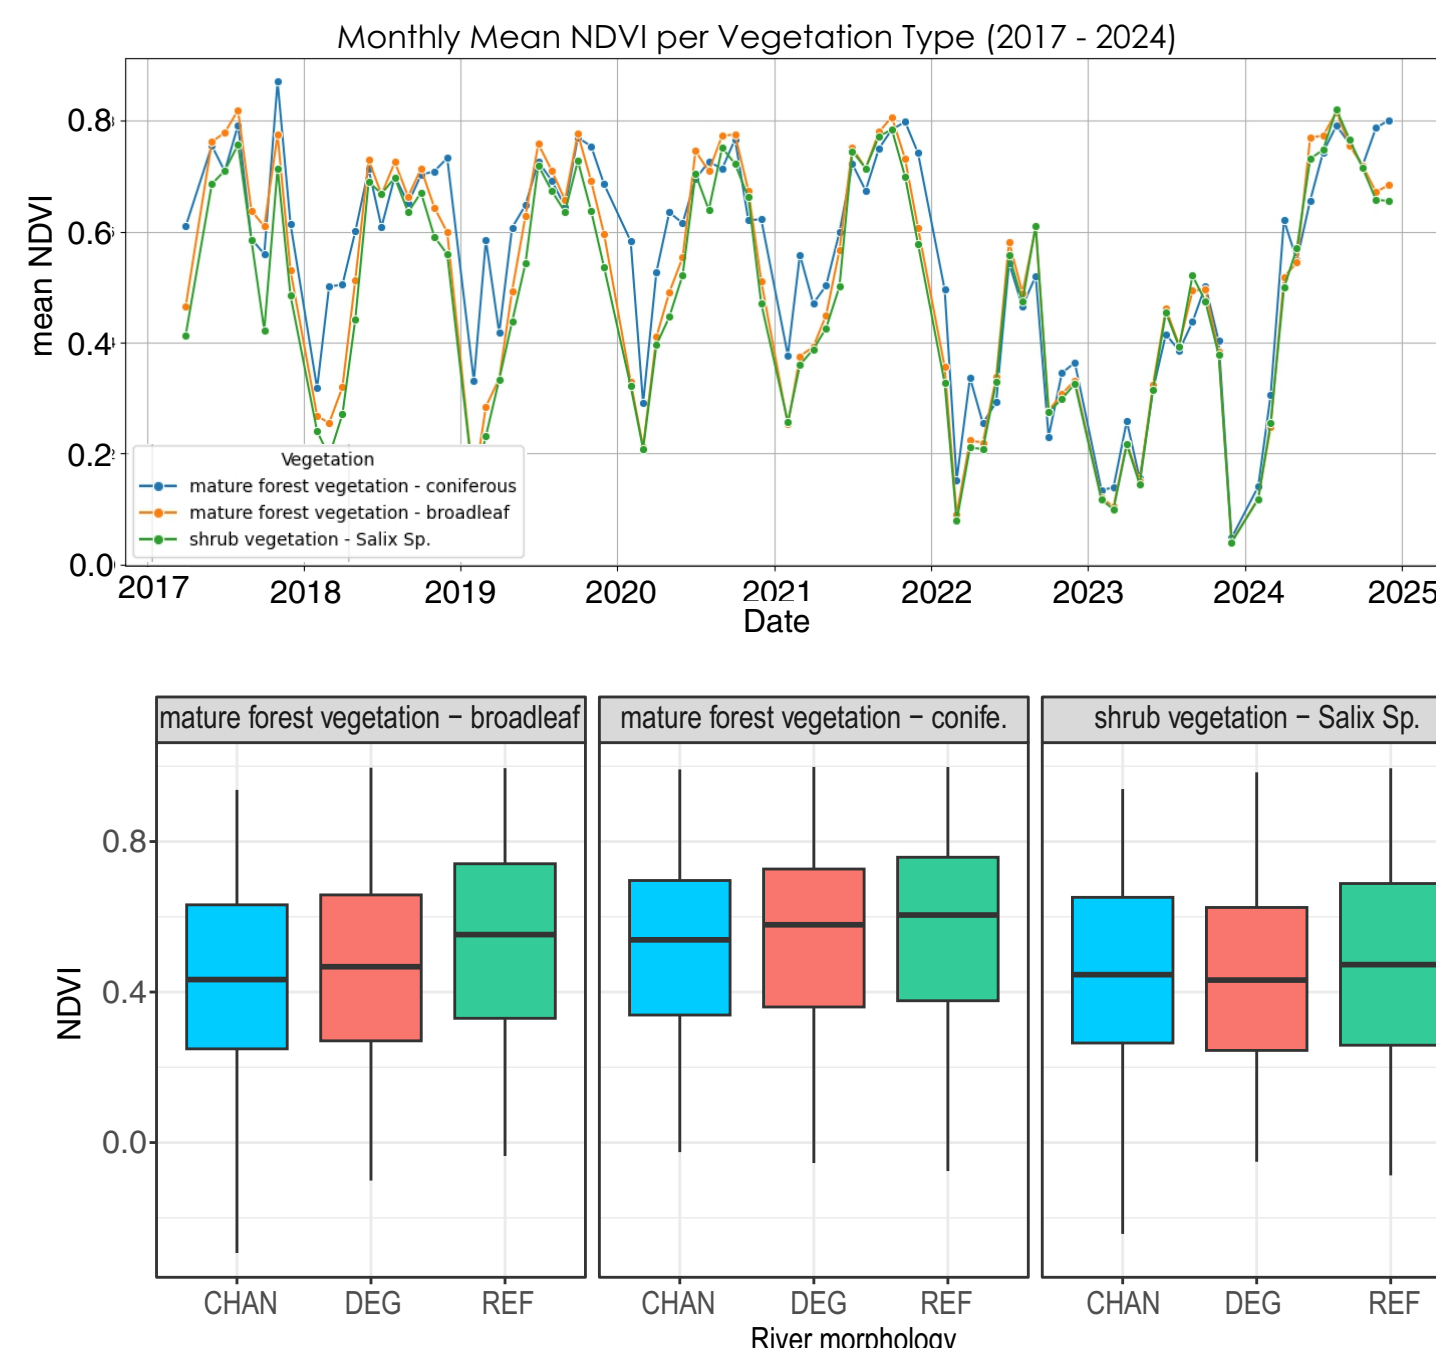
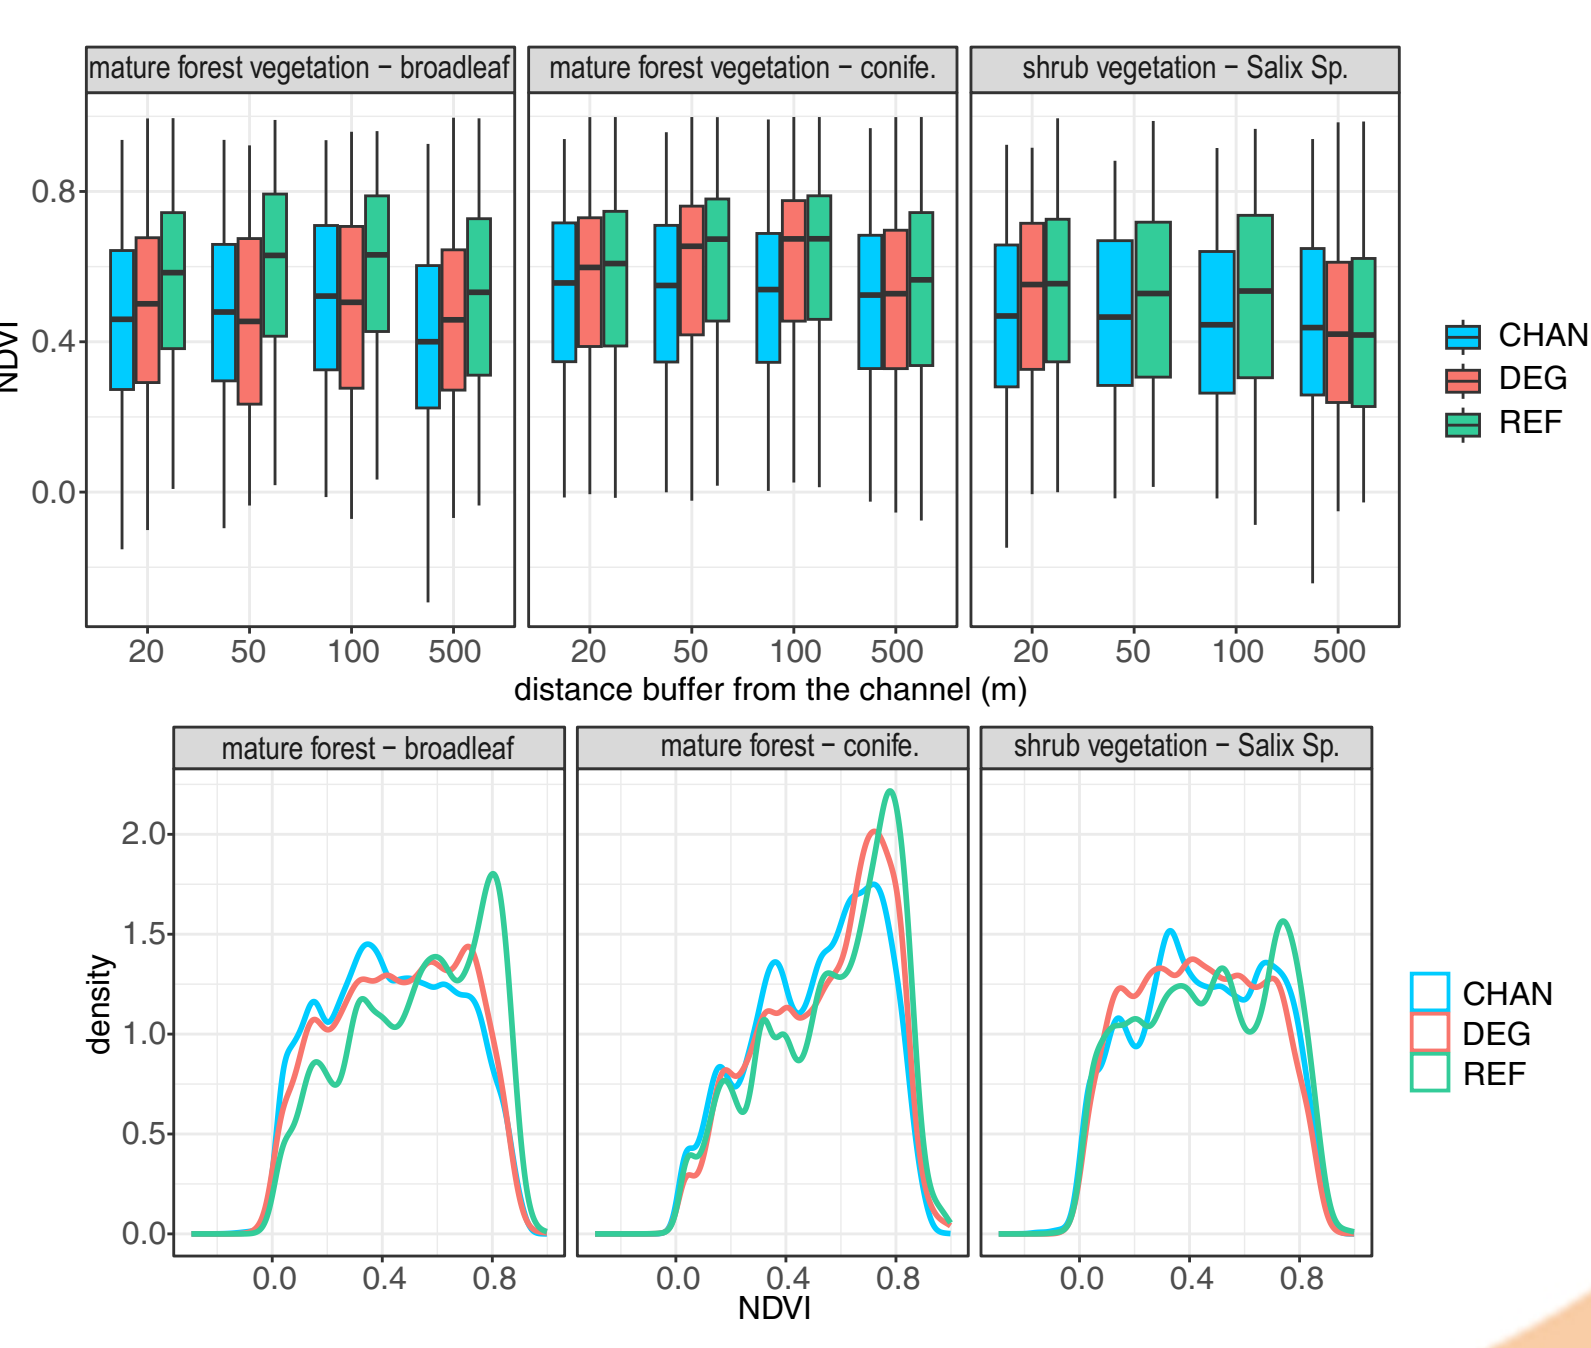
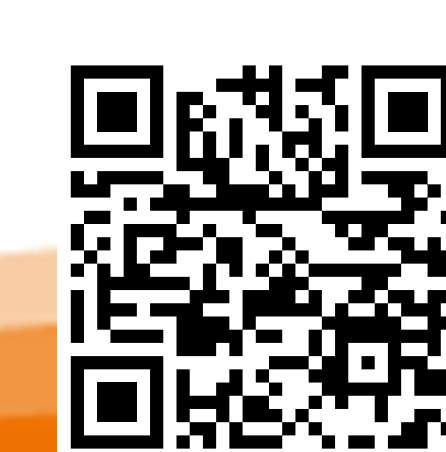
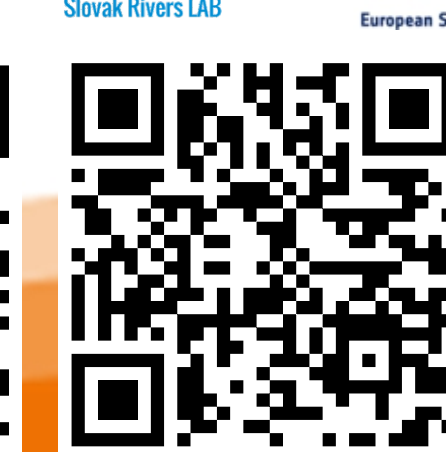
## 6 Vegetation monitoring

- NDVI - proxy-value for vegetation health
- negative response of degraded river reach
